REDEVELOPMENT PLAN, ALEXANDRIA BANK BUILDING

A Redevelopment Plan For The Bank Of Alexandria Building

EXHIBIT B
EXISTING PHOTOS

To: Mr. Clifford H. Rusch, Deputy City Manager
From: Charles Everly, Director, Building & Mechanical Inspections
Subject: Inspection of Exterior and Interior Conditions
of the Bank of Alexandria Building
Date: May 5, 1978

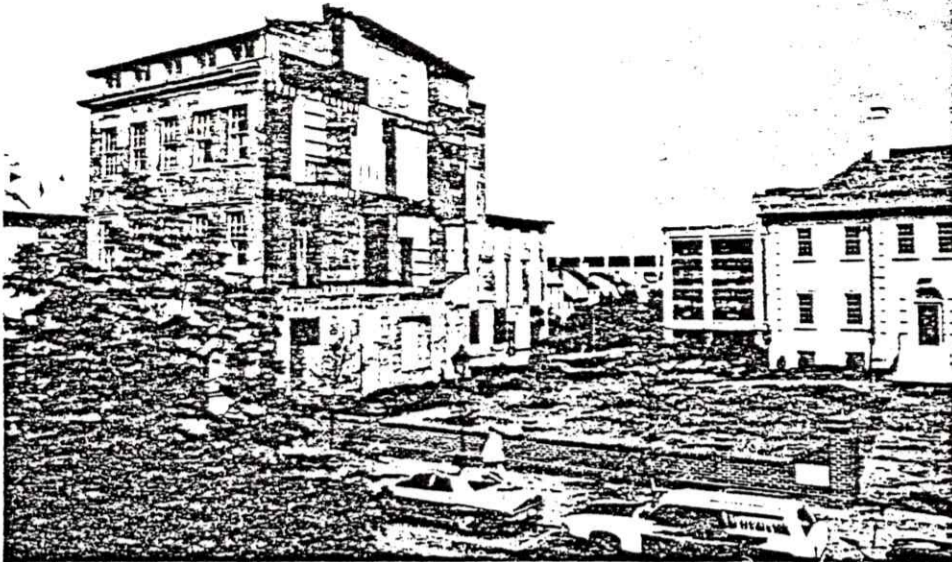
VIEW OF SOUTH AND WEST ELEVATION. NOTE TEMPORARY PATCH OF EXTERIOR AND DETERIORATION OF WALLS.

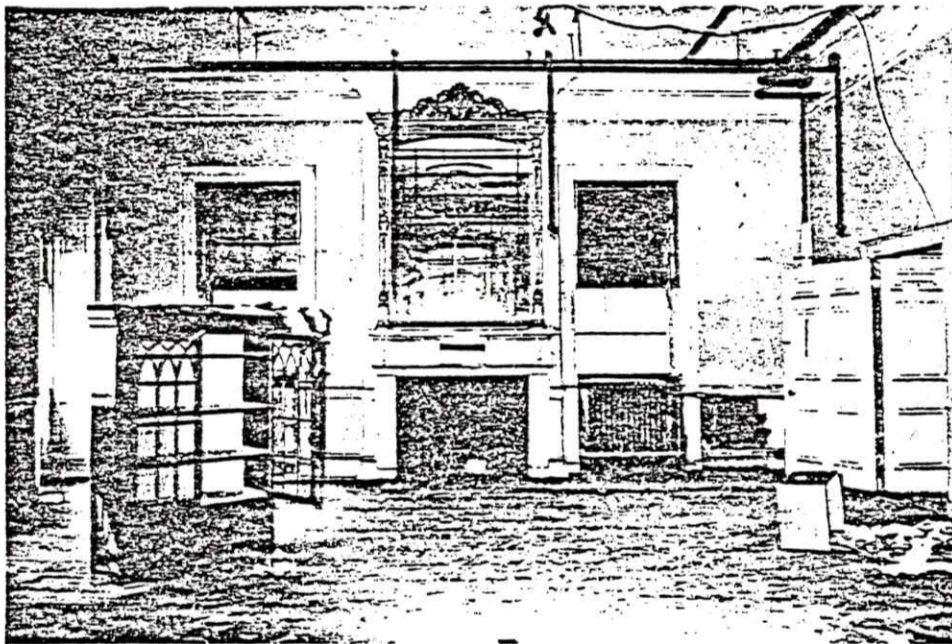
PHOTO OF MAIN LOBBY. NOTE INADEQUATE LIGHTING, DETERIORATED WALLS AND CEILING,
AND EXPOSED PLUMBING.

Fireplaces, rebuild fire box.
Repair lobby walls as required.

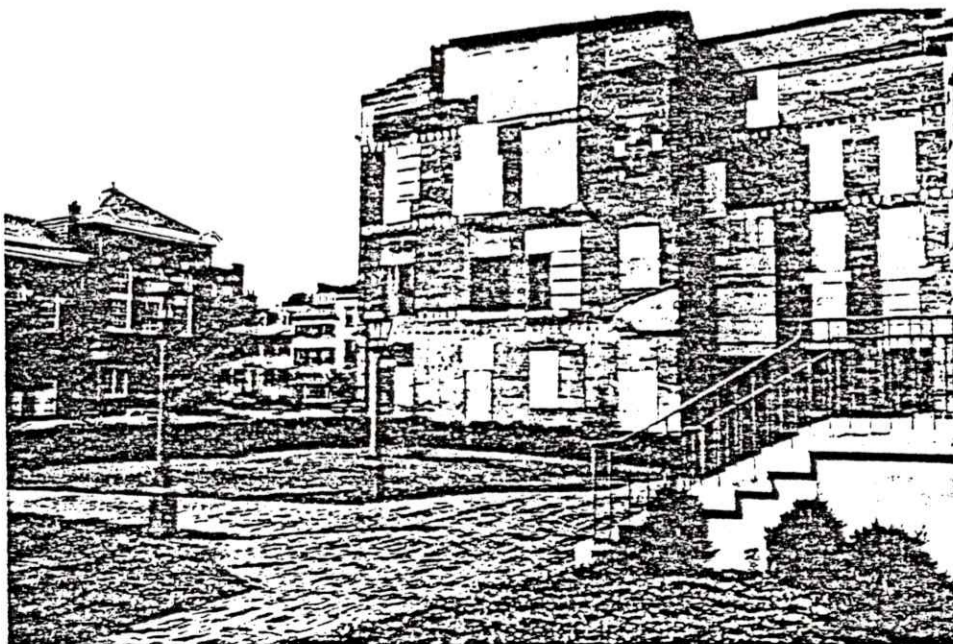
VIEW OF SOUTH ELEVATION. NOTE DETERIORATED CONDITION OF EXTERIOR WALLS.

OUTSIDE FRONT - FAIRFAX STREET
Repair all windows to original design (all sides)
Restucco, entrance steps
Repair masonry and repoint up entire building.
Rebuild all chimneys.

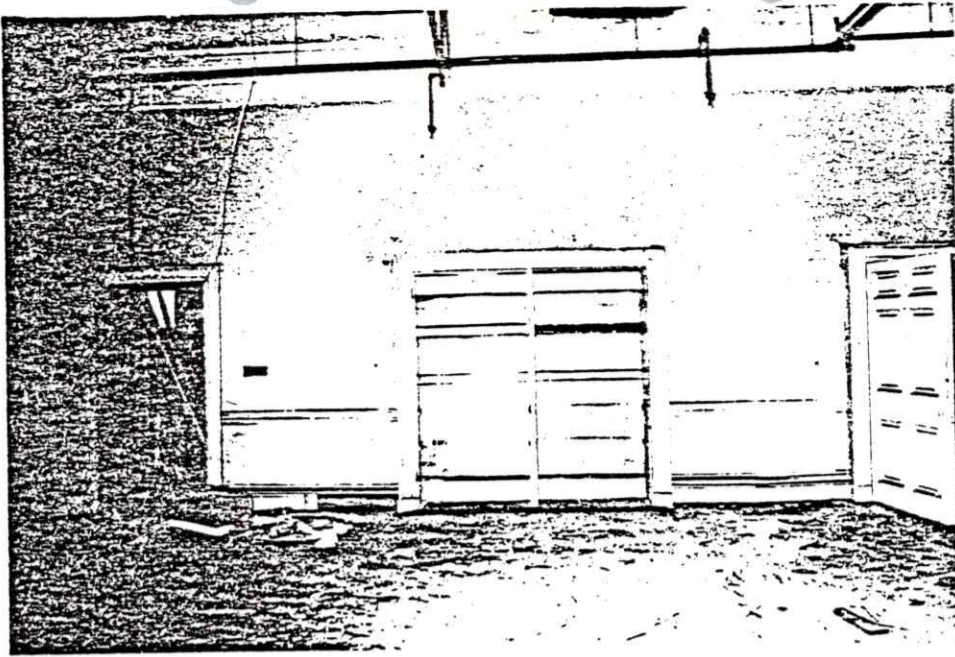
INTERIOR PHOTO SHOWING TYPICAL CONDITIONS OF ROOMS. NOTE INADEQUATE LIGHTING, DETERIORATED WALLS AND CEILING.

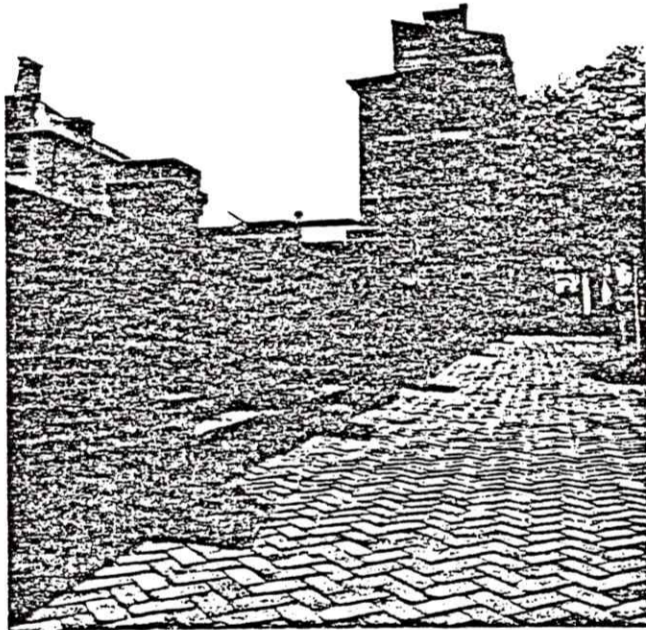
PHOTO OF EAST ELEVATION. NOTE DETERIORATION OF EXTERIOR WALLS, BOARDED WINDOWS, AND TEMPORARY REPAIRS TO TOP FLOOR.

Roof:
Roof will be removed and replaced, entire 4th. floor.
Rear addition roof will be removed and replaced.
Will install all new guttering with a new roof.

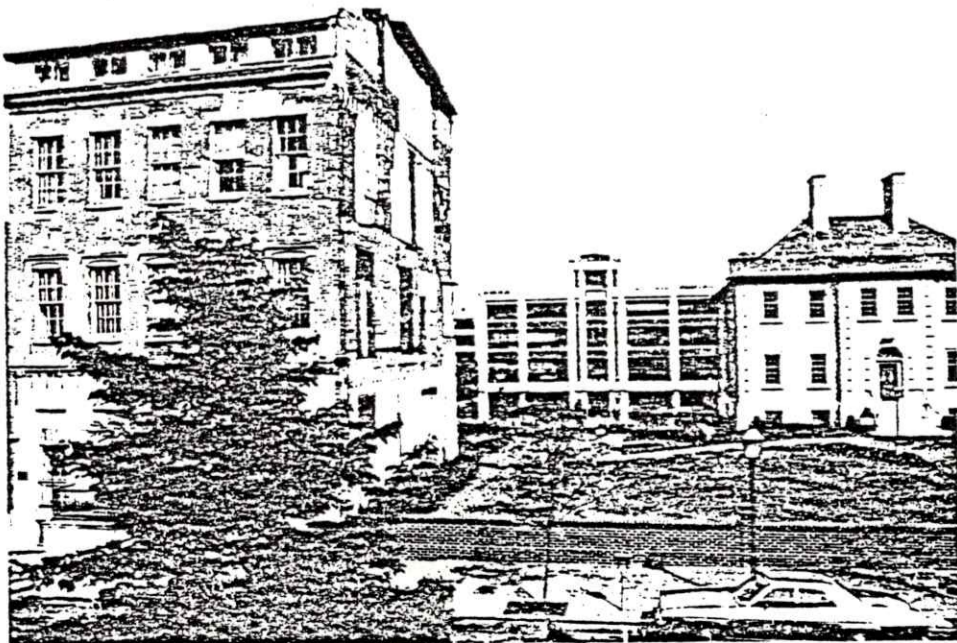
VIEW OF WEST ELEVATION, FRONT OF BUILDING. NOTE DETERIORATION OF EXTERIOR WALLS,
