## National Register of Historic Places Registration Form

Historic name: Goodman, Charles M., House

Other names/site number: VDHR file #100-5265

Street & number: 510 North Quaker Lane

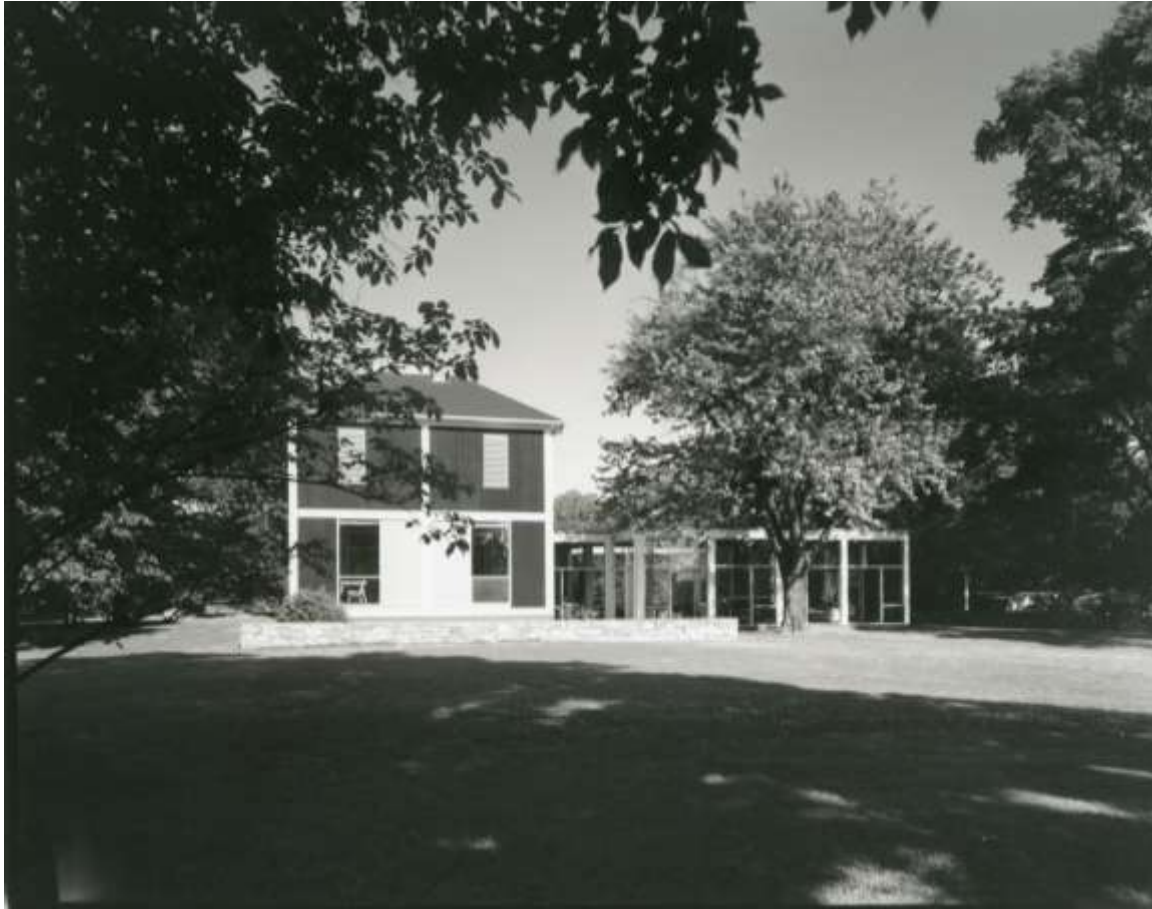
1 of 11: The Charles M. Goodman House, ca. 1954, showing the eastern façade. The original farmhouse (left) was constructed between 1873 and 1879. Goodman remodeled the house and added a glass pavilion (right) to the house between 1953 and 1954. From the Robert C. Lautman Photography Collection, box 33, courtesy of the National Building Museum, Washington, D.C.

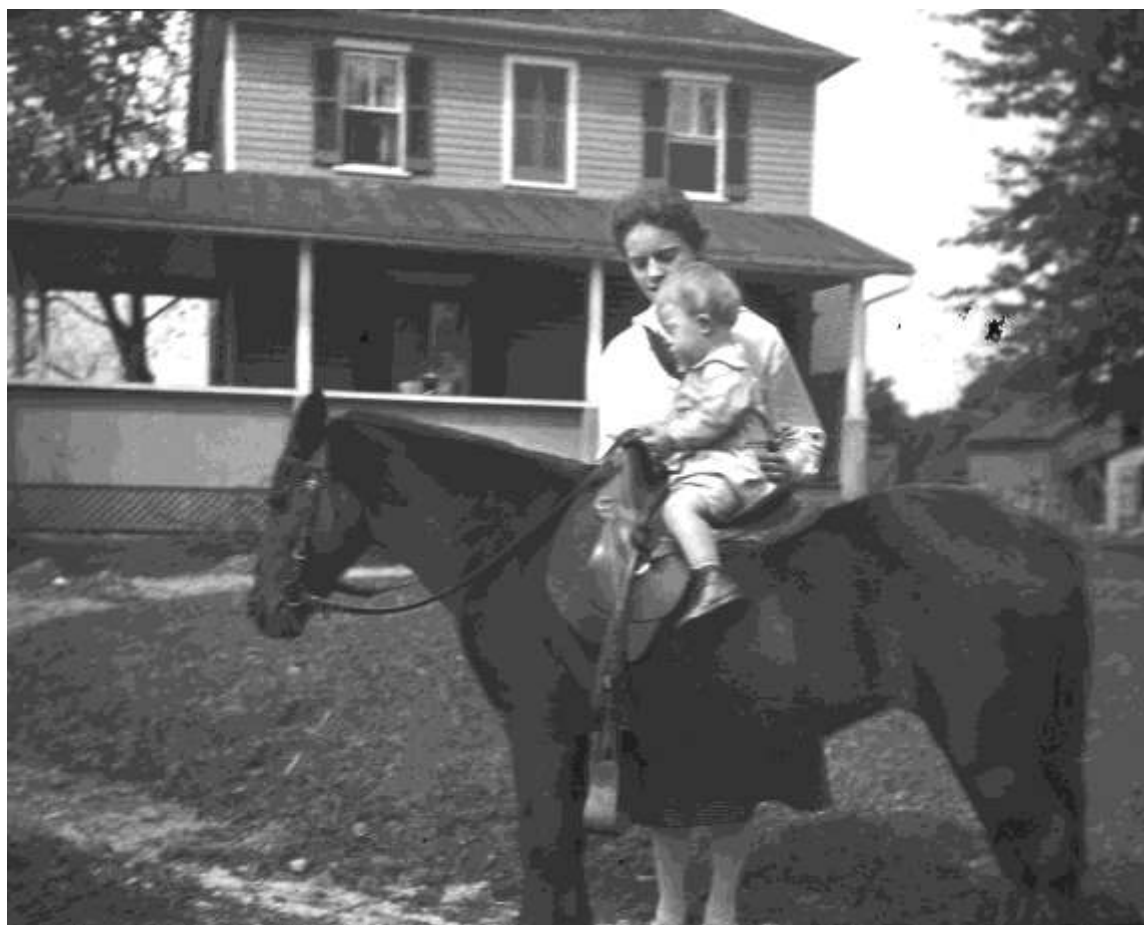
4 of 11: Photograph of the eastern façade of the farmhouse, possibly showing the child Peter McCrary (born January 30, 1934) and his aunt, Montgomery McCrary, ca. 1935-36. Photograph courtesy of Peter McCrary, Michael Wayne and Karen Ongley.

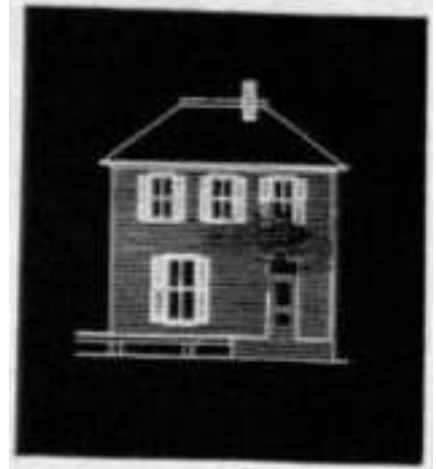
5 of 11. Comparison between a photograph of the eastern façade of farmhouse, published in 1954 (left), and an eastern elevation drawing of the farmhouse (right) published in 1956. Note the left image has been flipped horizontally to correct its orientation. Left image from Betty Pepis, "Old Frame, New View" *New York Times Magazine* (November 21, 1954): 50. Right image from "A Top Builders' House Architect Tries a New for Tomorrow," *House & Home* 9 (January 1956): 132.

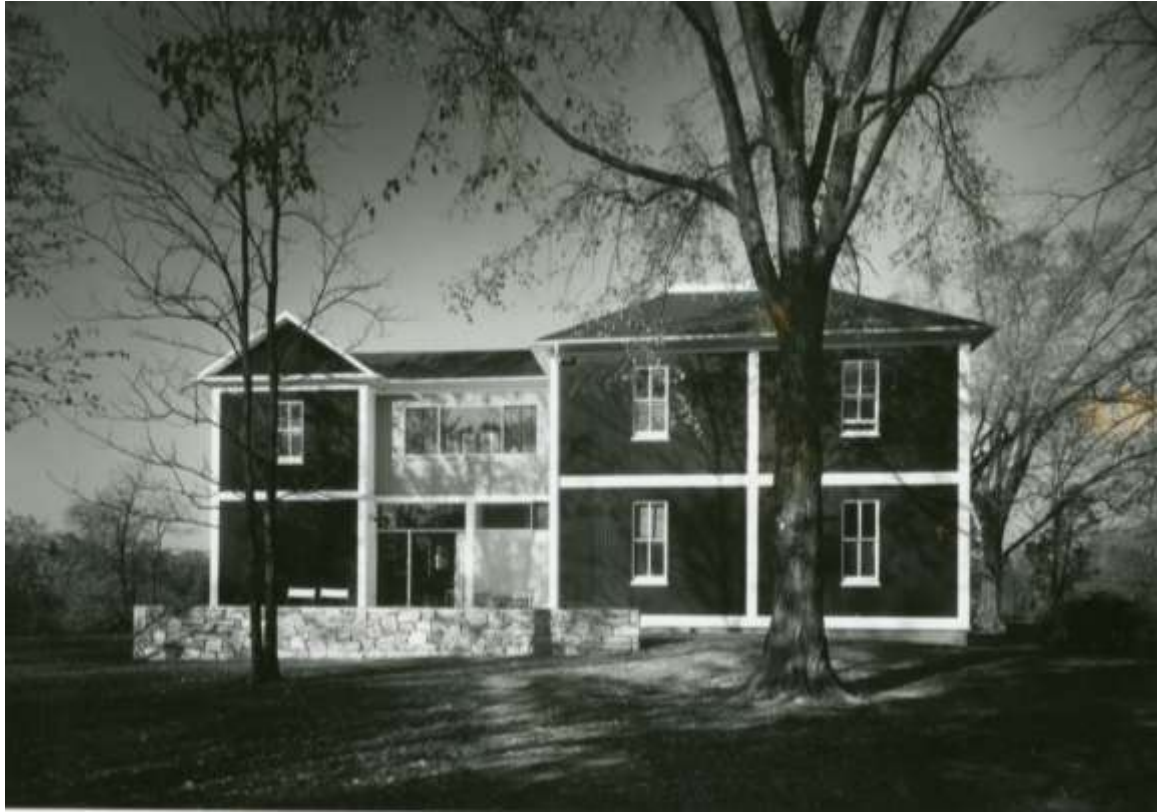
6 of 11: Photograph of southern façade of farmhouse post Goodman renovation, ca. 1954, showing the original farmhouse (right) and the additions of the hyphen (center) and gabled structure (left). From the Robert C. Lautman Photography Collection, box 33, courtesy of the National Building Museum, Washington, D.C.

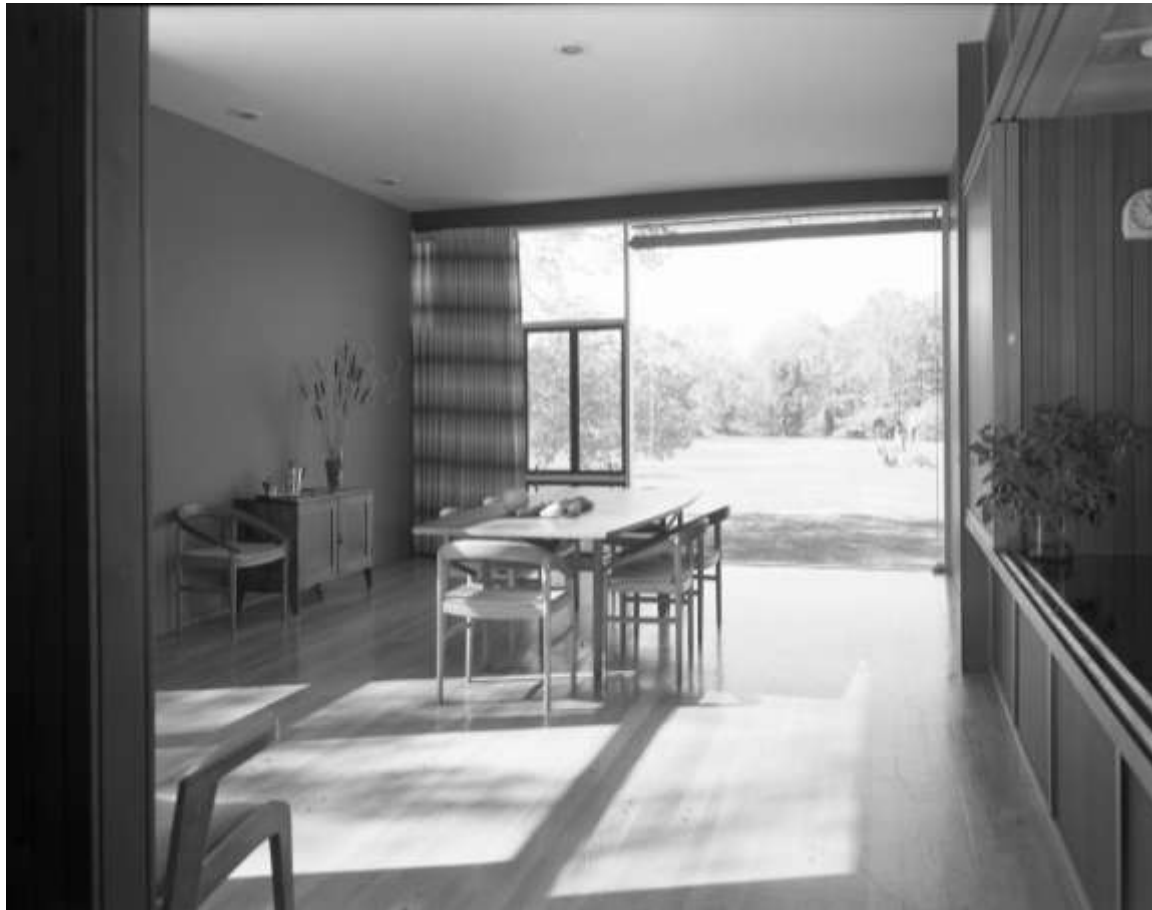
7 of 11: View of dining room looking west through the plate glass to a large lawn, ca. 1954.

This image shows rails to the right which allowed panels to be closed across the pass through to the kitchen. The dining table is by Jens Risom and the dining chairs are by Hans Wegner. Note that additional furniture was later placed in this room, as visible in figure 21. From the Robert C. Lautman Photography Collection, box 35, courtesy of the National Building Museum, Washington, D.C.

To communicate with the dining room, Goodman opened up a wall between the kitchen addition and the dining room in the old farmhouse, placing a low built-in counter with chairs as an informal eating area. Goodman also included mechanisms to close off the kitchen from the dining room. He placed tracks above and below this opening on the dining room side where panels could be closed, keeping the kitchen and its services hidden from formal dining. Originally, a swinging door communicated between the dining room and kitchen, though the door is no longer in place. In keeping with the original farmhouse feel, Goodman installed at the western end of the kitchen a modern Dutch door, split in half so that the top portion could be opened for air circulation while the bottom could remain closed.

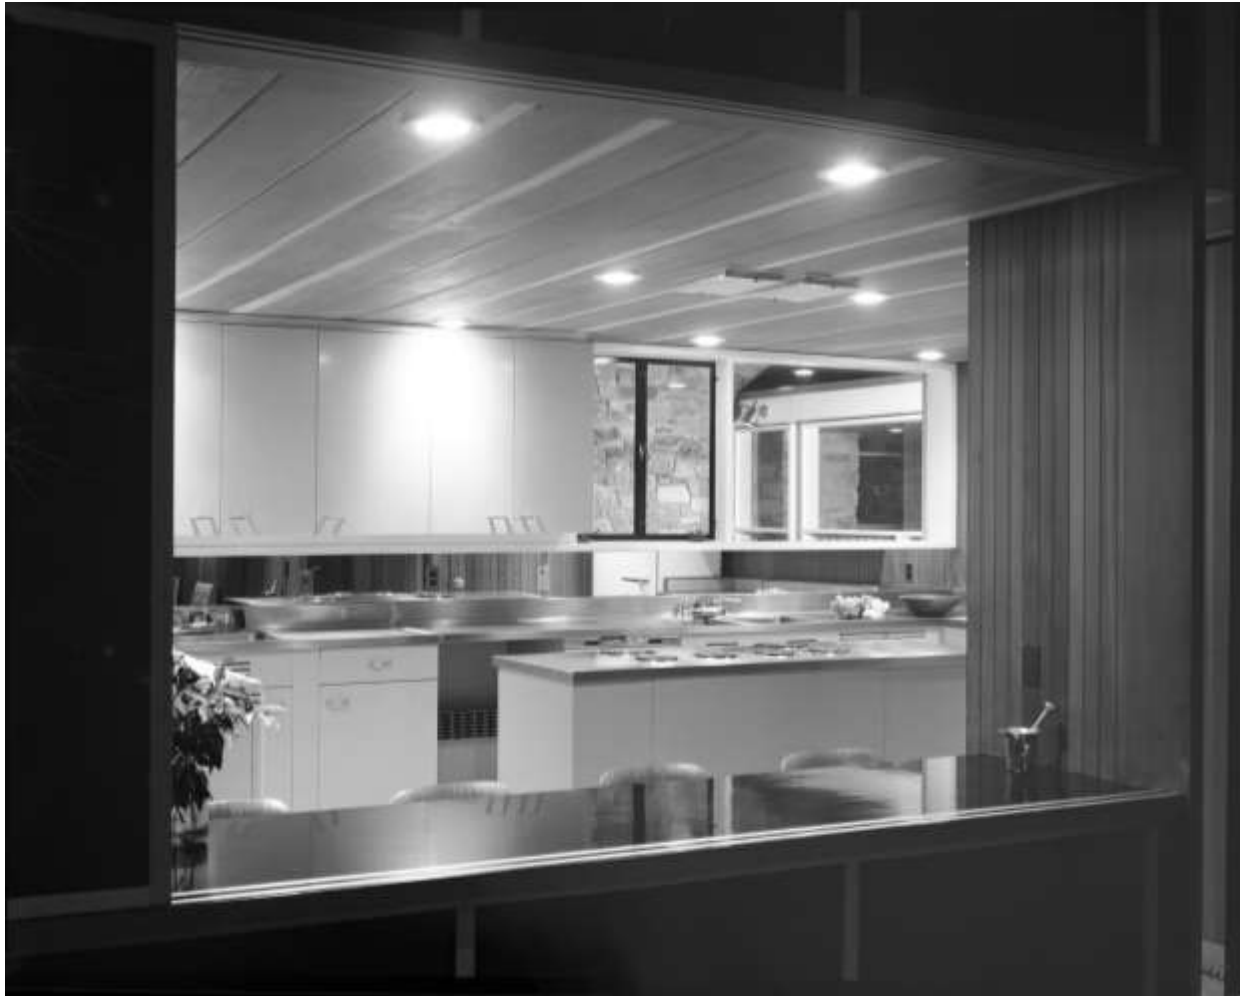
8 of 11: View of kitchen with white St. Charles steel cabinets, simple metal pulls, mirrored back splash, stainless steel countertops, and wide plank wood paneling on the ceiling with industrial fans over the cooktop, ca. 1954. From the Robert C. Lautman Photography Collection, box 35, courtesy of the National Building Museum, Washington, D.C.

courtyard, and covered terrace.<sup>9</sup> In the kitchen addition, which was tucked along the northern side of the hyphen of the old farmhouse, Goodman created a thoroughly modern space made from prefabricated industrial materials. Goodman selected white steel St. Charles cabinets that ran along three of the kitchen walls with simple metal pulls, stainless steel countertops, and a mirrored backsplash, in the words of Goodman himself, “to make the kitchen surfaces look bigger and to help light them up.”<sup>10</sup> An island contained the cooktop, and overhead were two large industrial exhaust fans. Goodman continued his experimentation with wood paneling in the kitchen, here using wide 1-by-10 v-joint paneling on the ceiling.

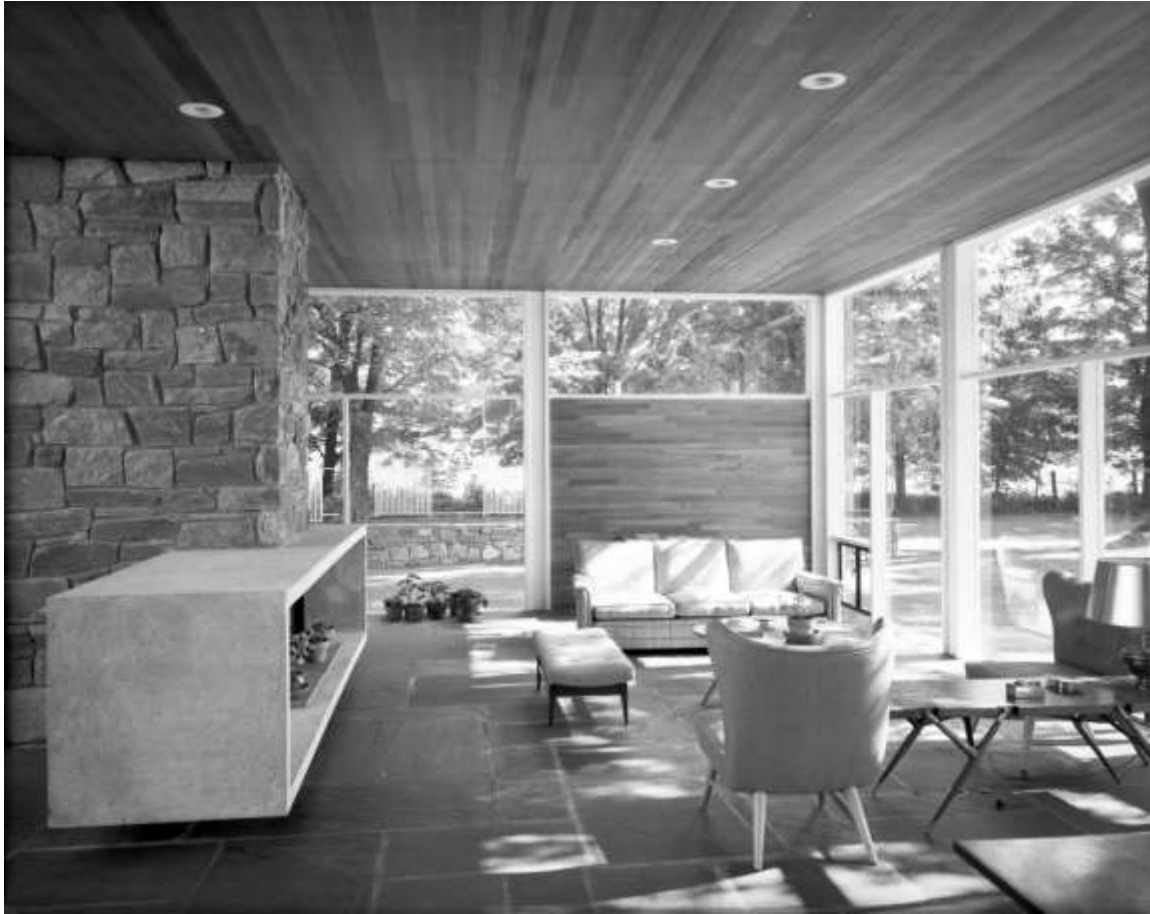
9 of 11: The glass enclosed living room of the Goodman addition, ca. 1954. Visible here are the cantilevered concrete fireplace, stone chimney, wood paneled ceiling, and flagstone floors with radiant heating. While most of the prefabricated panels were filled with plate glass, some like the panel above were filled with wood paneling. The bench is a Jens Risom piece. From the Robert C. Lautman Photography Collection, box 35, courtesy of the National Building Museum, Washington, D.C.

For comfort in the glass-enclosed living room, Goodman included radiant floor heating in addition to the fireplace. Goodman largely used single-pane glass instead of insulated glass, which was not widely available until the 1950s. Goodman was reported to have said that a sweater was the solution to a chilly glass room.<sup>12</sup> For privacy, Goodman did include curtains.

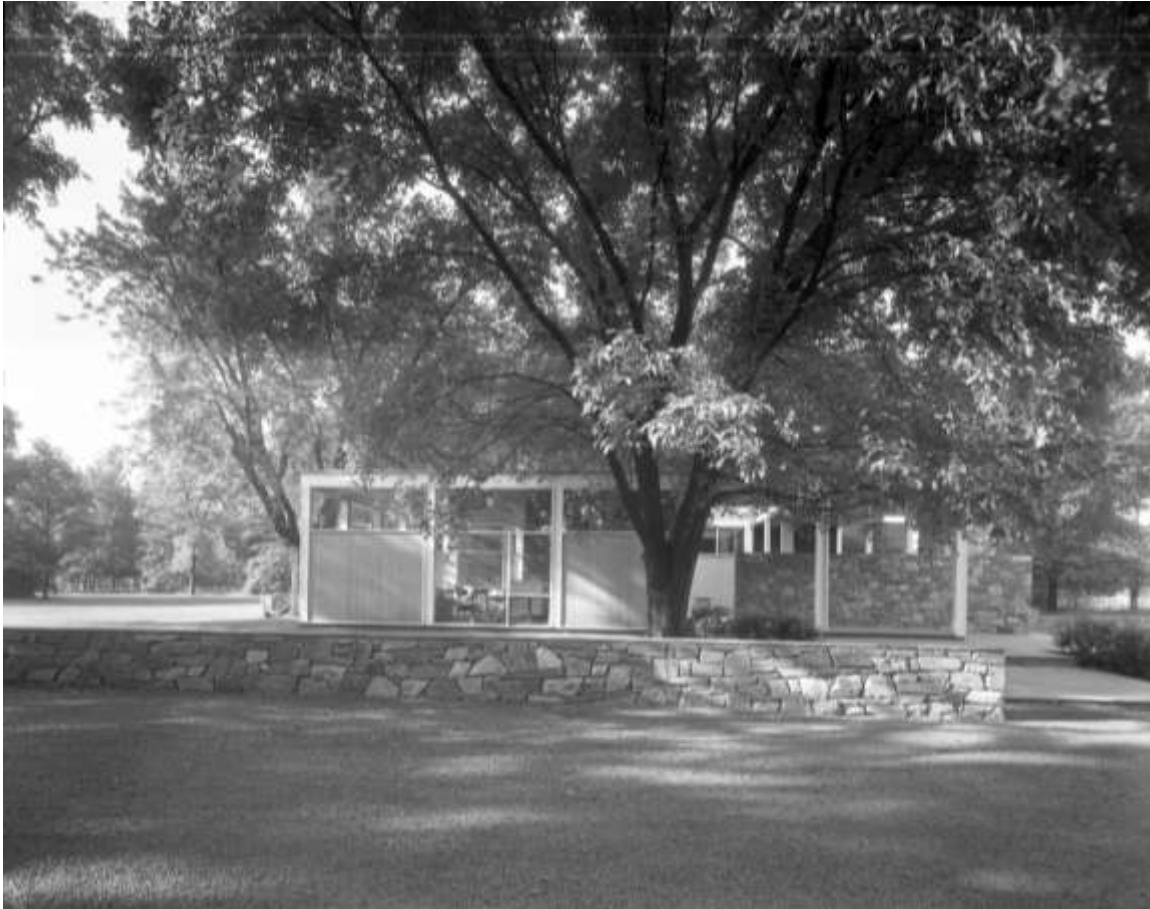
10 of 11: View of the Goodman addition from the entry courtyard, ca. 1954. The path to the house is at the right. The visitor is confronted first with a stone wall, obscuring the open courtyard beyond, and the entry door is hidden to the left. From the Robert C. Lautman Photography Collection, box 34, courtesy of the National Building Museum, Washington, D.C.

stone wall, which obscured the view of the courtyard beyond. Confronting this stone wall also meant the position of the front door was not obvious to the first-time visitor. Goodman placed the door to the left, perpendicular to the walkway and stone wall. Once inside the door, the large stone fireplace Goodman included within the addition shielded the view of the living room from the entry vestibule. The living room was revealed only after the visitor moved through the short foyer and turned to the right or south, where new sightlines were revealed. Directly ahead was the view of a short flight of stairs to the original farmhouse and a glimpse of a Victorian-era four-paneled door leading to the back parlor (what Goodman renamed the guest room in the 1954 published plan), creating a visual as well as physical connection between the new and old. As one was drawn along this axis to the older portion of the home, the floor to ceiling glazing drew the eye to the outdoor landscape. To the left or east was a small terrace; to the right or west, an open air courtyard and covered terrace. Goodman furnished the terrace as another living room, enticing the visitor to move toward this outdoor space.

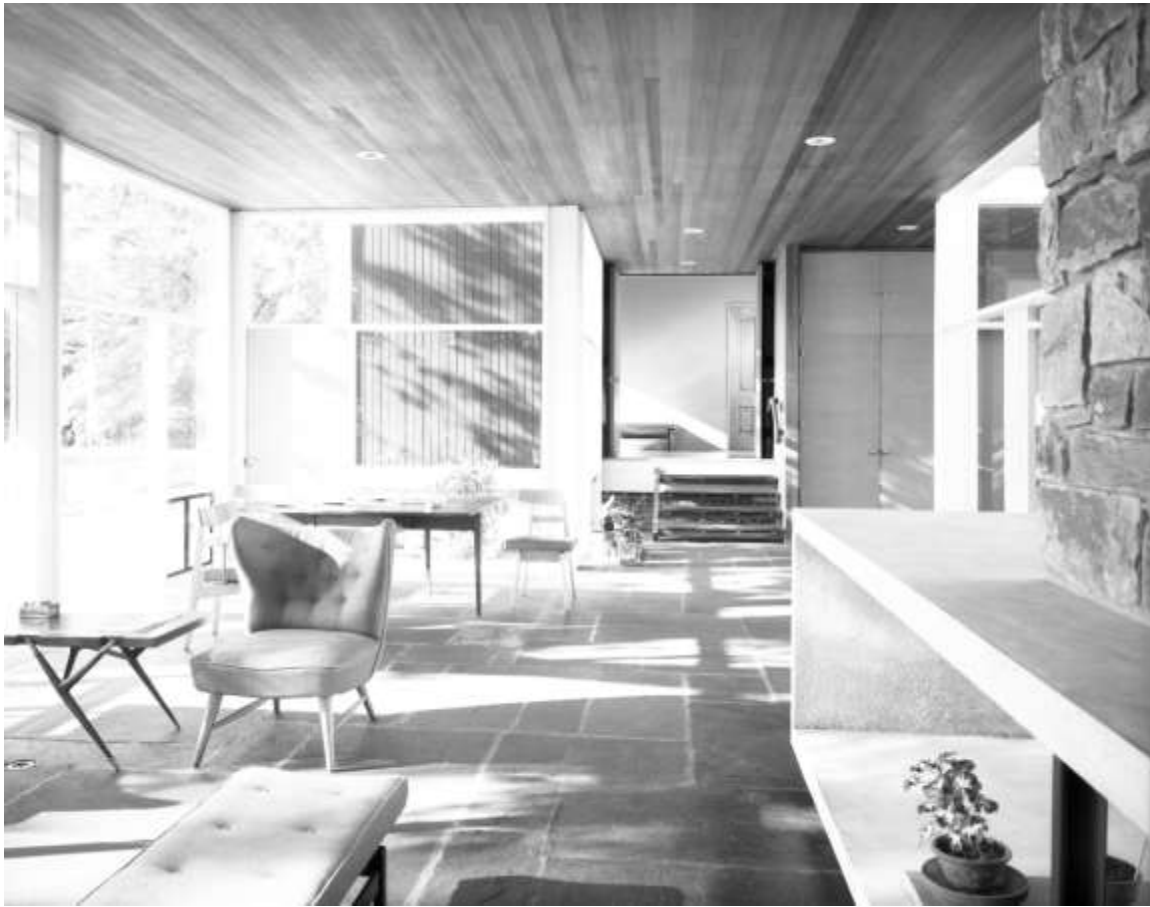
11 of 11. Photograph of the living room as one turns from the foyer, ca. 1954. Goodman created a circulation plan where the visitor is drawn through the living room toward the short stair that connects the new addition to the older farmhouse. Through the doorway, the Victorian-era four paneled door can be glimpsed, making a strong visual connection between the new and the old. Visible here also is a floor to ceiling cabinet at right, which has since been removed. The chairs around the table were designed by George Nelson. Note that this photograph has been flipped horizontally to correct its orientation. From the Robert C. Lautman Photography Collection, box 35, courtesy of the National Building Museum, Washington, D.C.
